Manhole Inspection Summary

Manhole # S47EE_007MH

Insp Date: **7/16/08 11:33 AM**

Location Address: **Patterson Park**

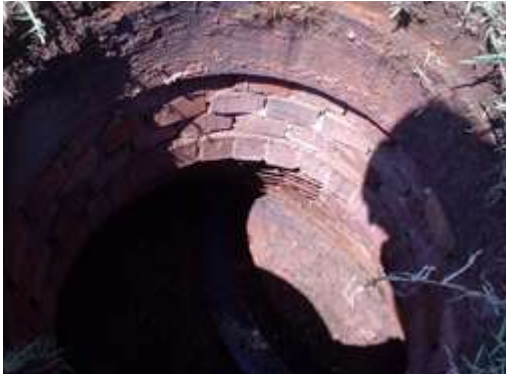
Defect 2

Frame Offset: **0.5** (in.) Condition: ☐ Sound ☐ Cracked ☒ **Leaks**

Frame leaks

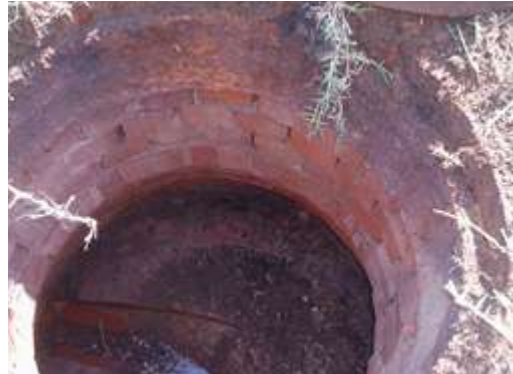
Defect 1

Infiltration: ☐ None ☐ Joint ☐ Cracks ☒ **Mortar** ☐ Roots ☐ Wall

Infiltration: ☐ None ☐ Joint ☐ Cracks ☐ Mortar ☐ Roots ☒ **Wall**

Infiltration

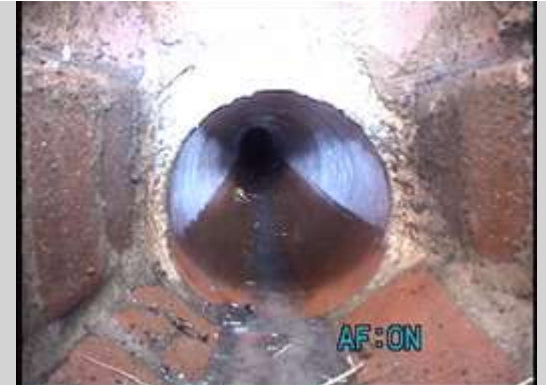
12 O'Clock Outflow

6 in. Circular Gravity Sewer
Pipe Out @ 12 O'Clock

Pipe Height: **6** (in.) Rod and Bar (Angled)
Pipe Material: **Clay** ☐ Pipe Lined
Invert Depth: **4.60** (ft.) Flow Characteristics: **Slow**
Deposits: ☒ None ☐ Mud ☐ Sludge ☐ Debris ☐ Grease
Silt Depth: (in.) Deposits Extent:
Infiltration: **None** Pipe Seal Cond: **Sound**

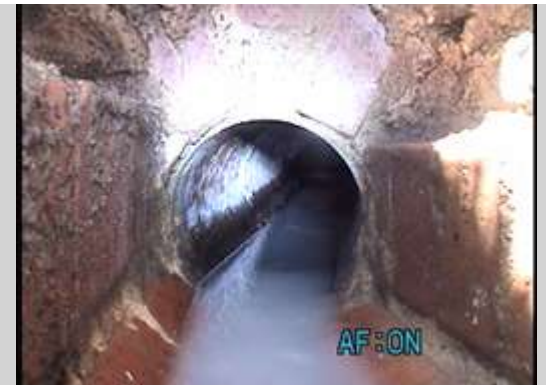
8 O'Clock Inflow

6 in. Circular Gravity Sewer
Pipe In @ 8 O'Clock

Pipe Height: **6** (in.) Rod and Bar (Angled)
Pipe Material: **Clay** ☐ Pipe Lined
Invert Depth: **4.55** (ft.) Flow Characteristics: **Slow**
Deposits: ☒ None ☐ Mud ☐ Sludge ☐ Debris ☐ Grease
Silt Depth: (in.) Deposits Extent:
Infiltration: **None** Pipe Seal Cond: **Sound**
